# **ELECTRODEPOSITION OF WEAR RESISTANT COATINGS**

**April 1990**

**Final Report**

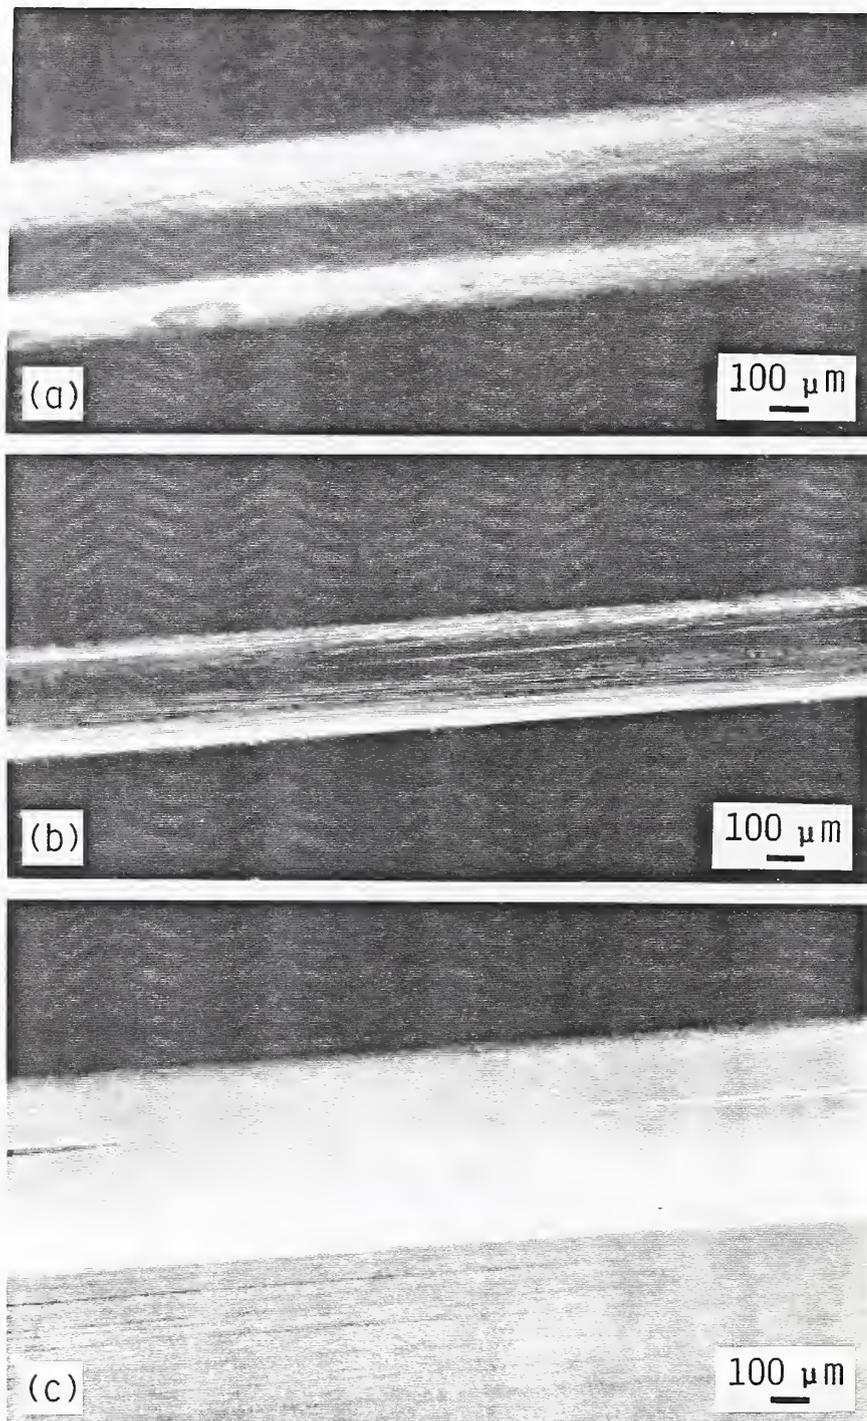
Figure 41. Optical photomicrographs of primary wiper blade #70278-2 plated with BEP chromium at  $70^{\circ}\text{C}$  and  $30\text{A}/\text{dm}^2$  ( $278\text{ A}/\text{ft}^2$ ). Both sides of chromium plated edge were tested for a combined 840,000 impressions (20 shifts). (a) As plated chromium on blade edge; (b) Worn chromium plated edge; (c) Wear scar on side of chromium plated edge.

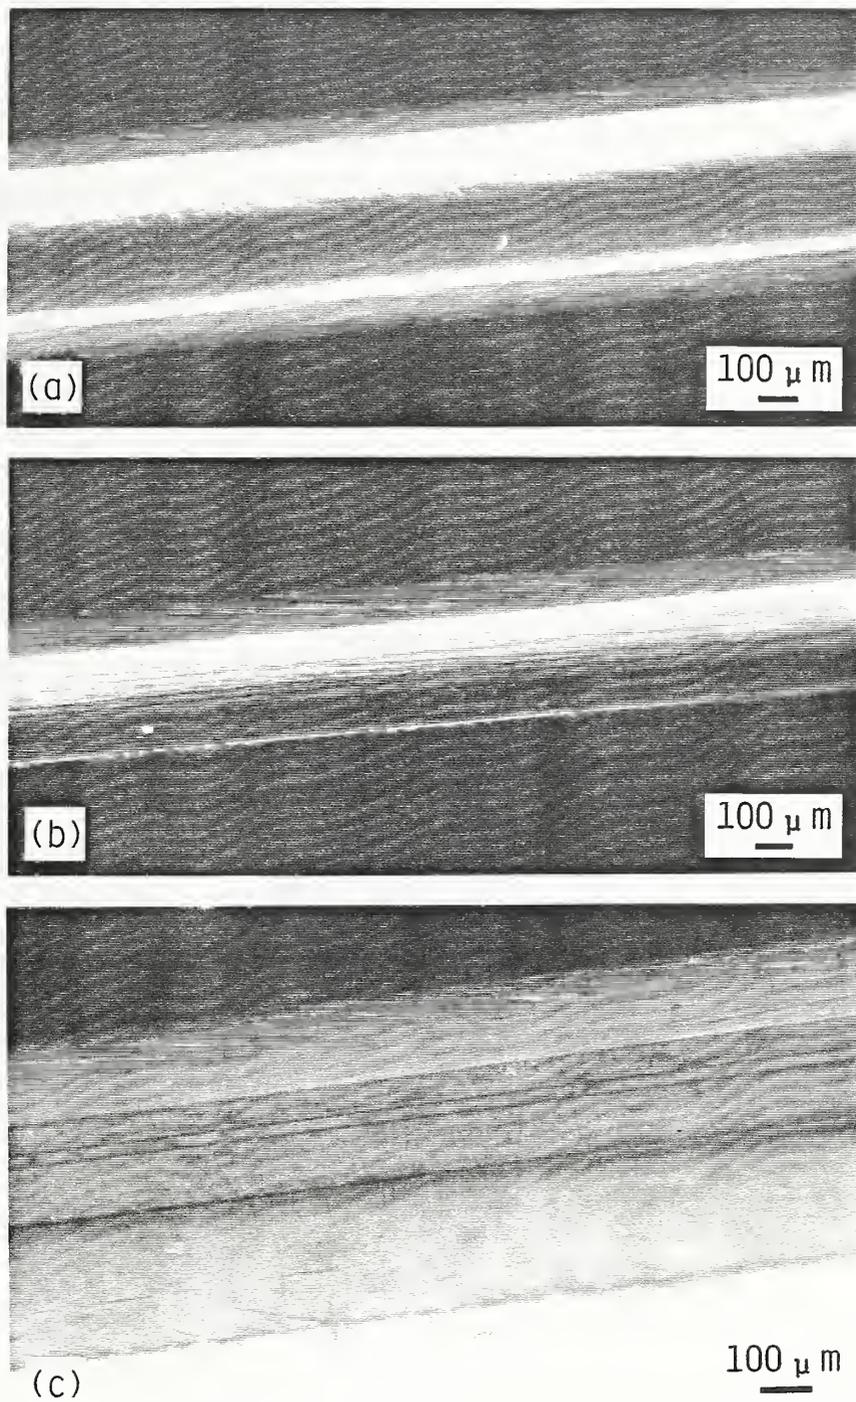
Figure 42. Optical photomicrographs of primary wiper blade #70278-3 plated with BEP chromium at 70°C and 30 A/dm<sup>2</sup> (278 A/ft<sup>2</sup>). Only one side of chromium plated edge was tested. (a) As plated chromium on blade edge; (b) Worn chromium plated edge; (c) Wear scar on side of chromium plated edge.

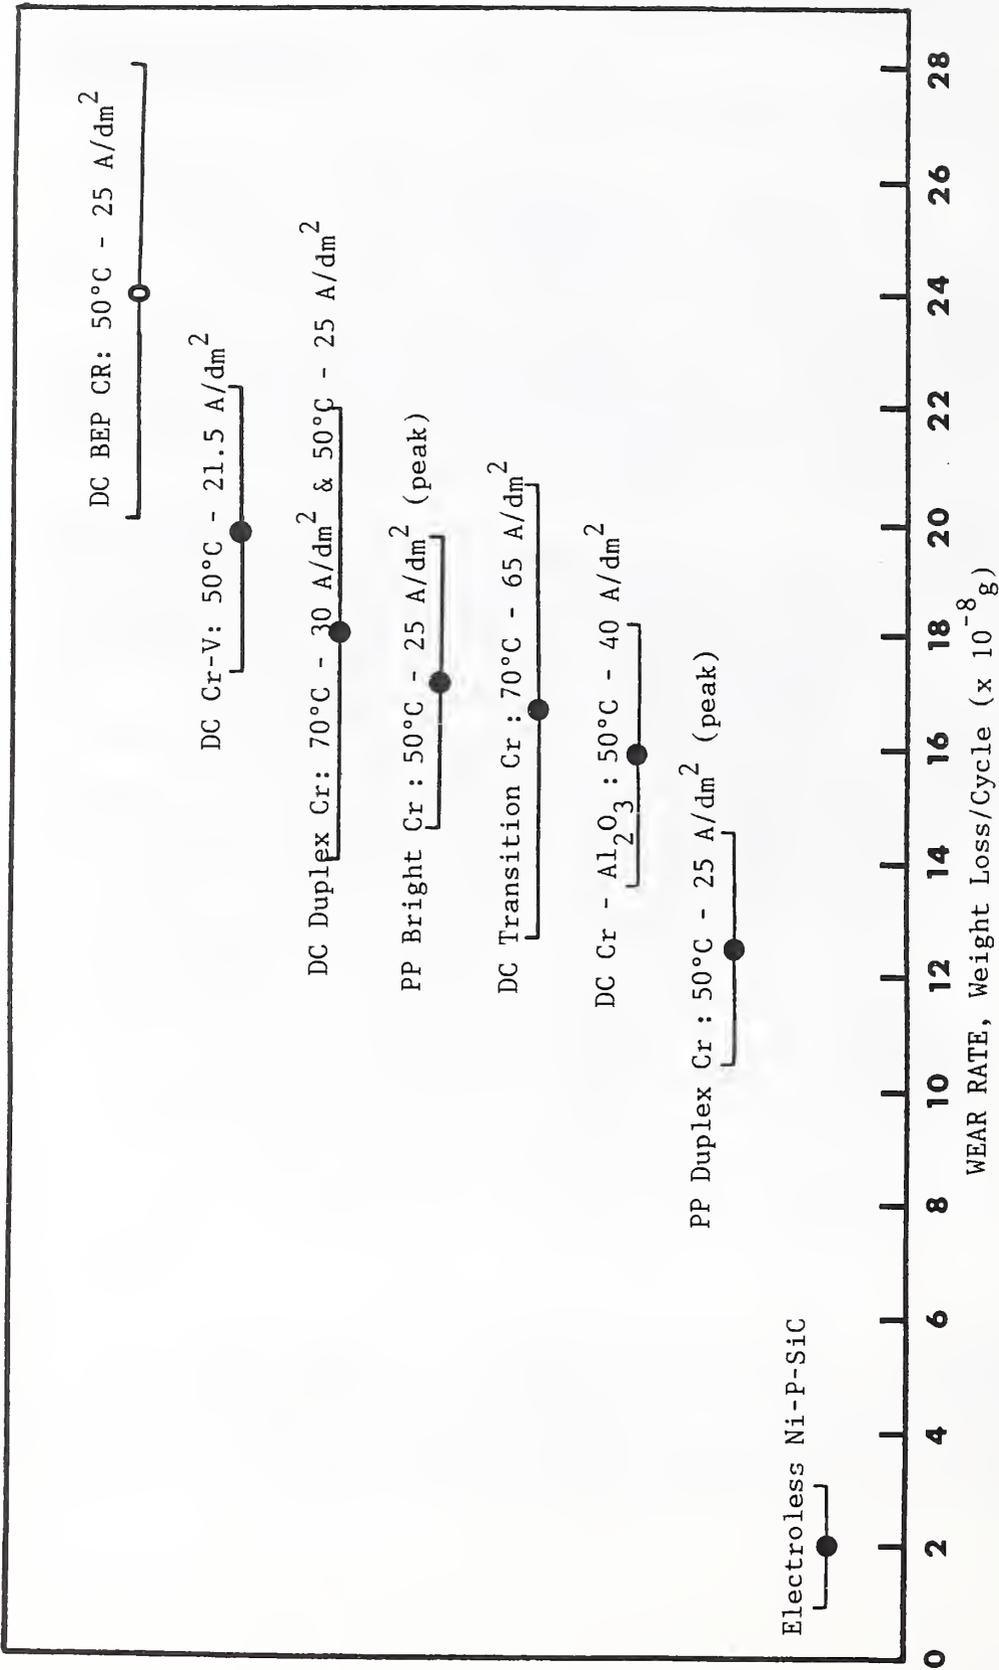
Figure 43. Wear rates of various coatings that were shown to have lower wear when compared to the presently used BEP chromium as determined on the abrasive slurry wear tester. Results are the average of five measurements plus and minus one standard deviation.
